Technical BULLETIN

► *Report on:* Fire Performance

► *Report on:*
Fire Performance

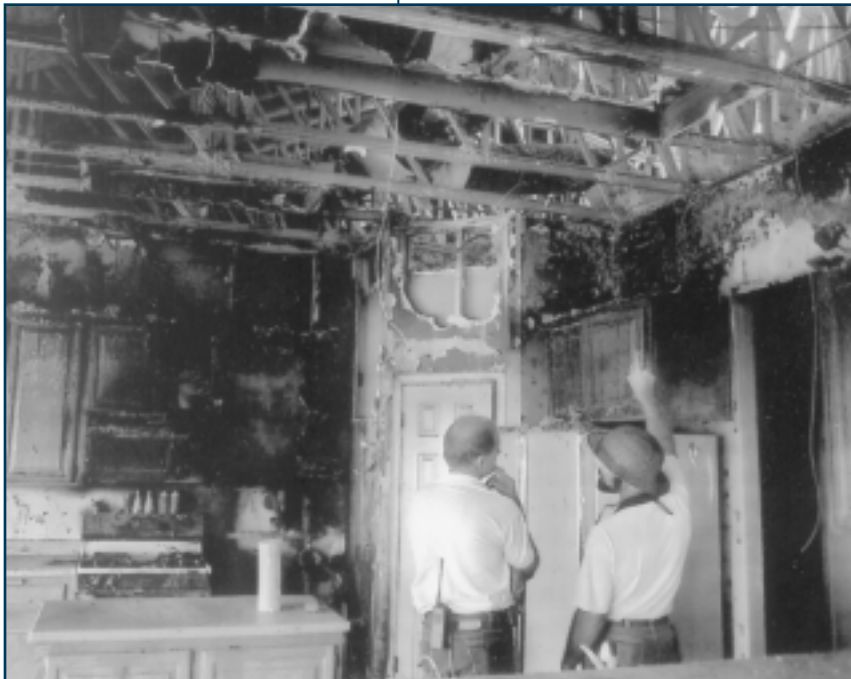
The fire caused \$75,000 in damages to the interior and personal property. In this steel framed home, the flames were contained to the kitchen with smoke damage elsewhere and no structural failure of the steel roof trusses or wall frames occurred. If this

According to firefighters the fire reached temperatures of 650 to 760°C (1200 - 1400°F) and yet no structural failure of the steel frame occurred. The firemen commented that if the structure was of traditional wood frame, the damages would have been more extensive.

An analysis was performed on the steel truss cord and wall studs in the area most affected by the fire. Physical testing showed that the mechanical properties of the members still met the specifications for structural steel studs. The zinc coating on the steel remained intact and in some places there was evidence of alloying with the steel substrate to produce galvaneal, a product commonly used in manufacturing automotive body panels. As a result of this analysis, none of the framing members needed to be replaced.

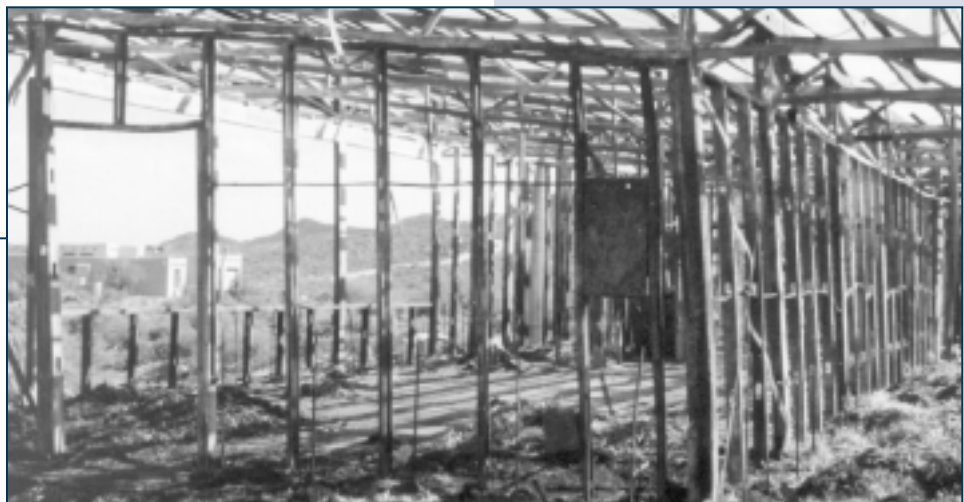
Since this building was not yet finished the fire spread quickly. When Tucson fire response teams arrived the structure was fully engulfed and a decision was made to let the fire burn itself out. The fire reached temperatures of 650°C (1200°F) which was hot enough to severely cracked the concrete floor slab. When the smoke cleared the steel framing was still standing. Doug Emans, assistant fire chief at the scene was surprised. He said "a similar wood structure would have collapsed". Another fire fighter commented that wood would have been "toast". In fact 2" x 6" lumber used to frame around some of the openings was just that. With the framing still standing it greatly reduced the fireman's task of checking the debris to ensure all hot embers were out.

believe the roof trusses and walls were still standing after all the sheathing had burned off.

"Steel framing still standing after the fire."
